## How Does the Kennel Kit Work?

These pictures are of testing done with Deep Seal and Top Seal—which make up the Kennel Kit. The left section of the slab is bare, the middle section was treated with DS. The right section was treated with DS which was allowed to dry one day, then the area dampened with water. The TS was applied on a dampened surface which was still dark gray.

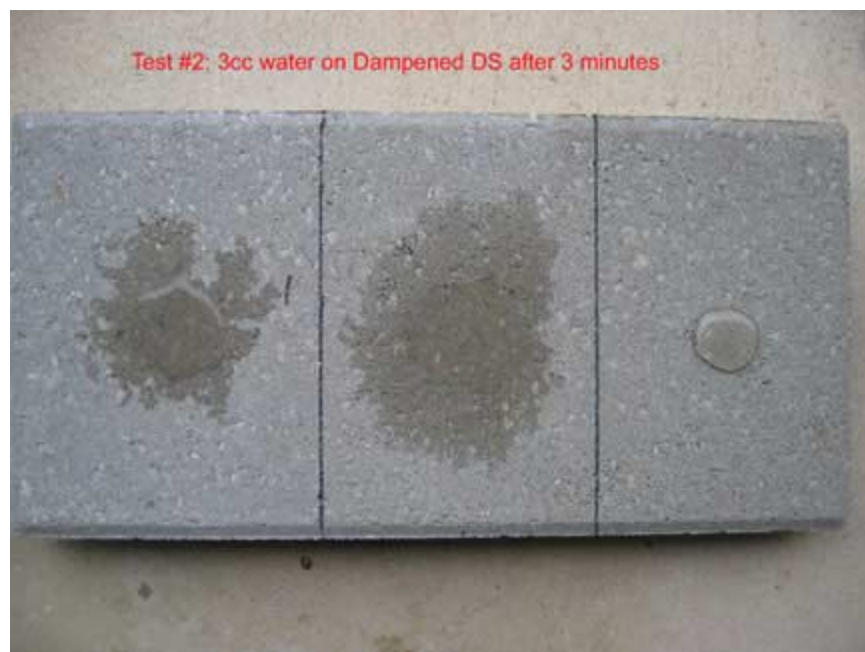
Below, the middle section after 3 minutes covers more than twice the area of the water on the left, bare section

You will notice that over time, the water darkened area in the middle section grows larger than the left spot. The illustrates that on the bare concrete the water tends to soak straight down into the concrete, while in the middle section, the presence of the DS beginning about 1-2 mm below the surface prevents that kind of absorption. Instead, in the middle section the water can only go down about 1-2 mm and then it starts spreading out horizontally...increasing the size of the moisture darkened area.

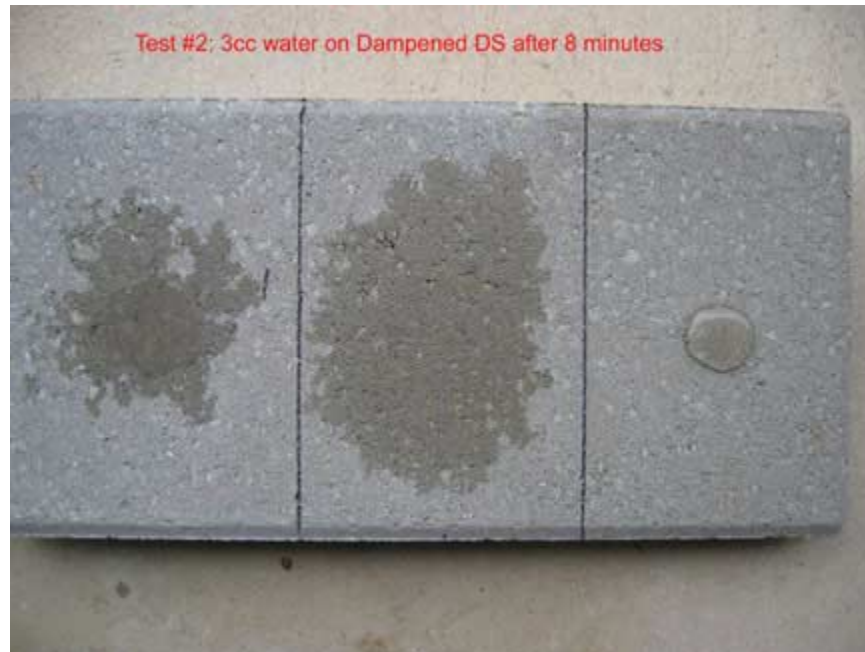
After 8 minutes, the center section has continued to grow as the water spreads out horizontally because the Deep Seal is blocking it from going down into the slab.

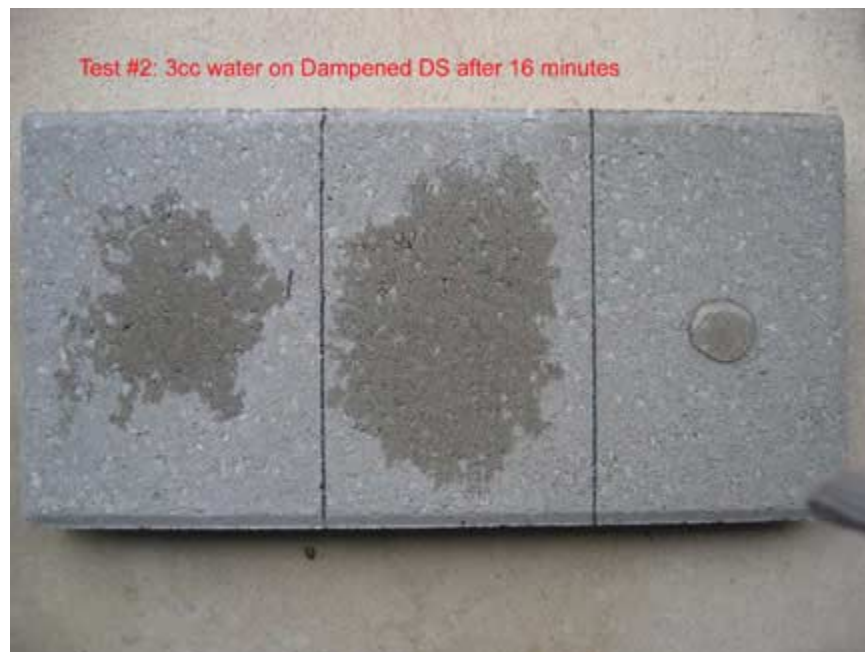
While hard to see at this resolution, there is still slight moisture on the surface in the two left sections, bare and DS only... the beaded 3 cc.s on right on the DS/TS has not changed at all.

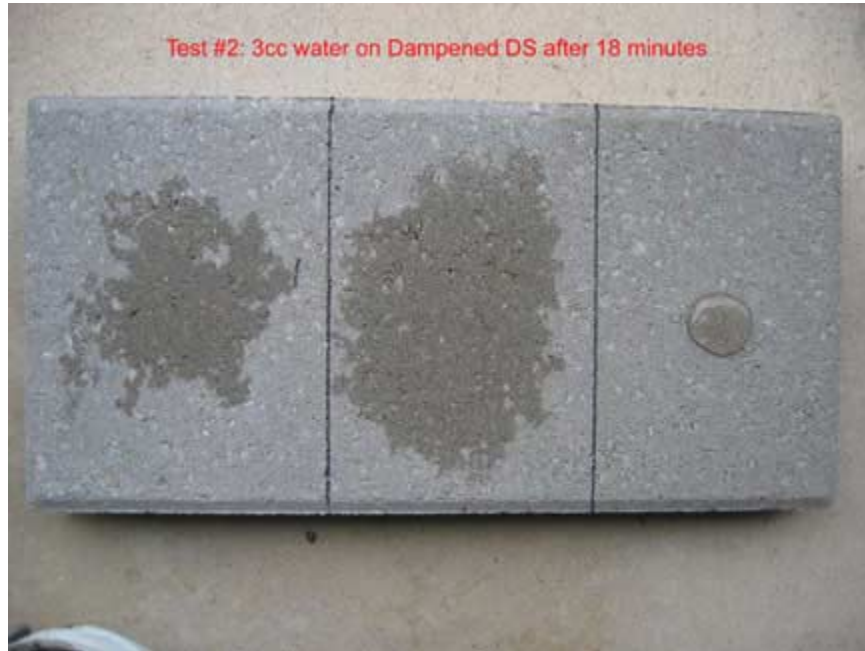
By 18 minutes, there is no water on the surface, it has all soaked in on the bare section and spread out wider in the middle section where the DS blocks the penetration under the surface. This illustrates that Deep Seal does NOT put a film on the surface, instead the top 1-2 mm are devoid of product and constitute a "bondable" surface for the application of adhesives, paints, surface coatings, overlays, stampwork etc.

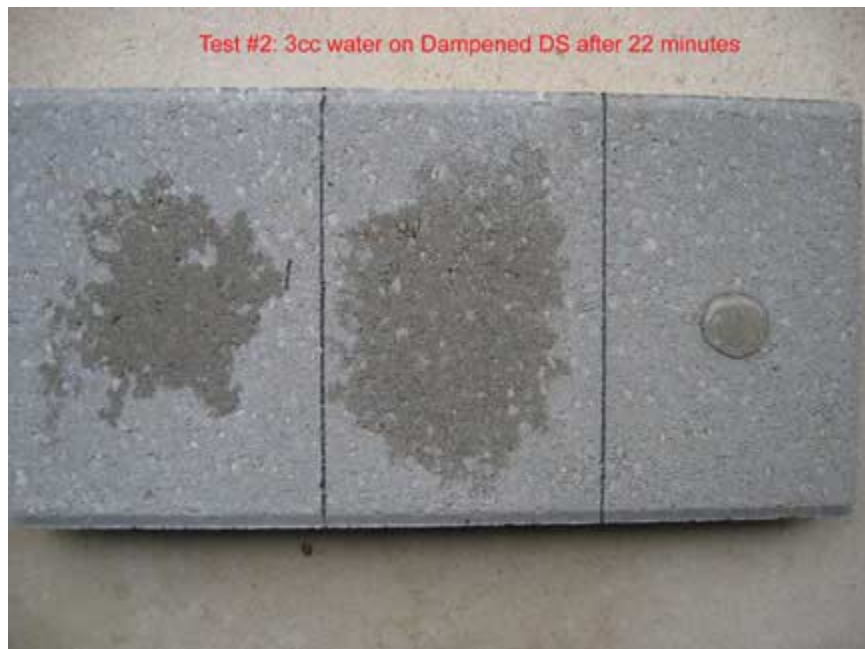
After 22 minutes you can notice that the middle section is starting to lighten up in color around the edges and at some places in the darkened (wet) area... the bare section on the left is not showing this lightening or drying.

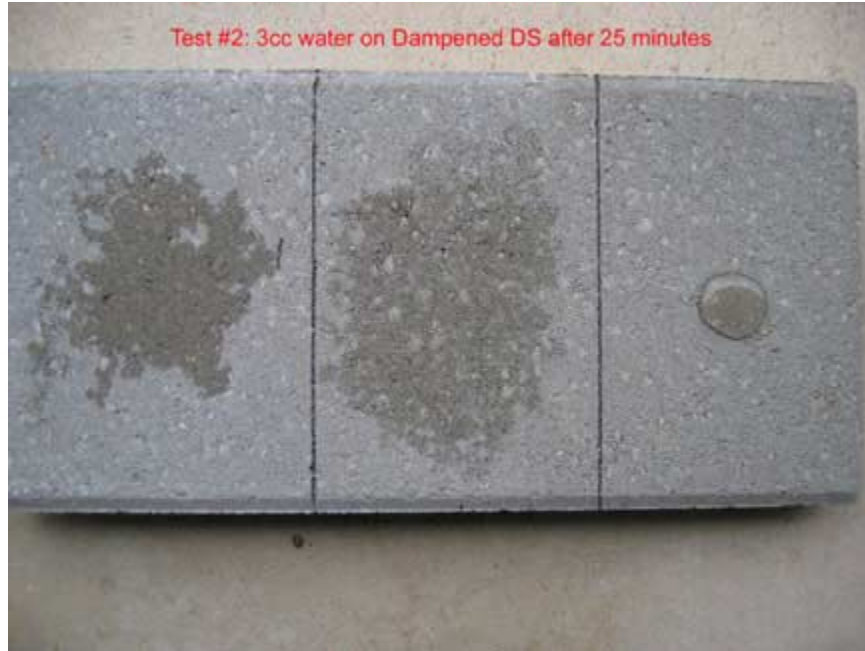
By 25 minutes the difference in drying between the left and middle sections is becoming more evident... with the DS treated area getting dry faster than the untreated section on the left, which is darker in color, indicating more moisture present.

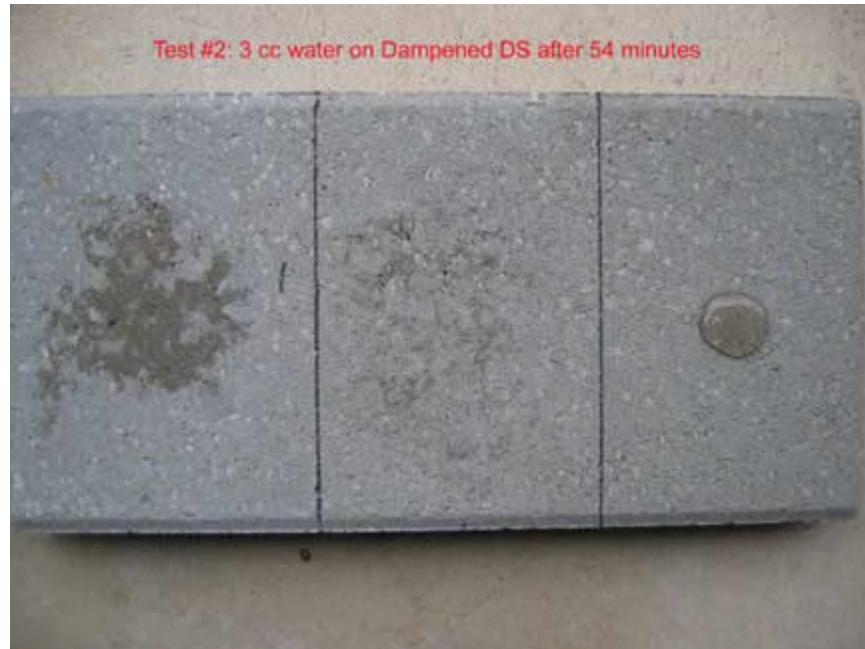
After just under an hour, the 3 ccs of water has almost completely dried where it was applied on top of the Deep Seal....while the 3 ccs applied on the left untreated section still shows dark indicated presence of water.

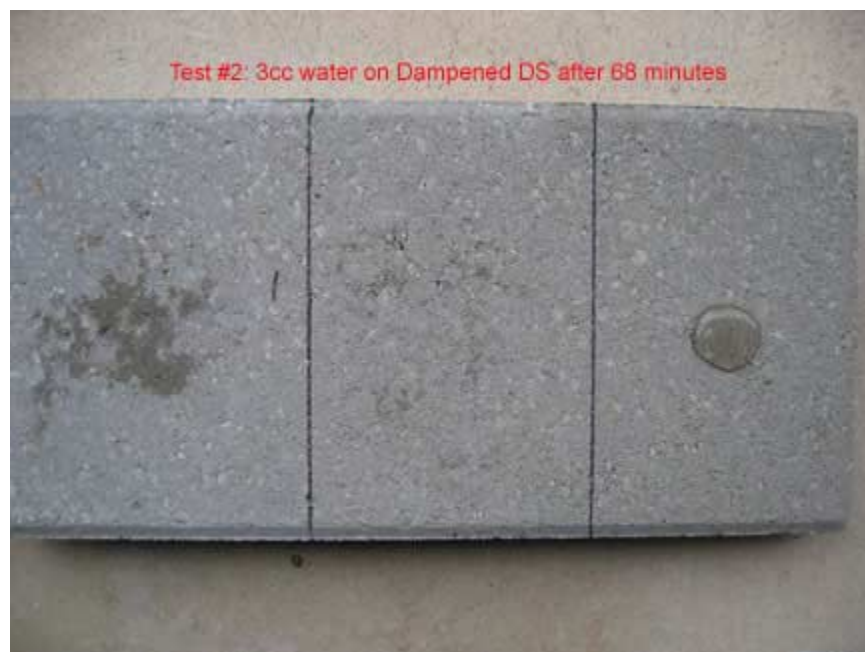
After a little over an hour, the middle DS treated section is pretty much dry, but water still evident on the left. The right Top Seal section shows the 3 cc's of water still beaded with none having soaked in. This graphically shows that concrete treated with DS does not stay damp or wet as untreated concrete. This test was only 3 cc's of water...the size of the bead on the right. If it had rained on this slab, say 1/2 inch of rain or more, the slab on the left would have been totally saturated and full of water... appearing dark gray over the whole surface...while the DS treated section would appear as it does below... because the only water that could have soaked into the DS treated section would have been in the top 1-2 mm of the surface... which as you can see dries quickly. This test was done in southwest Missouri where humidity is relatively high, and no sun hit this slab during the test.

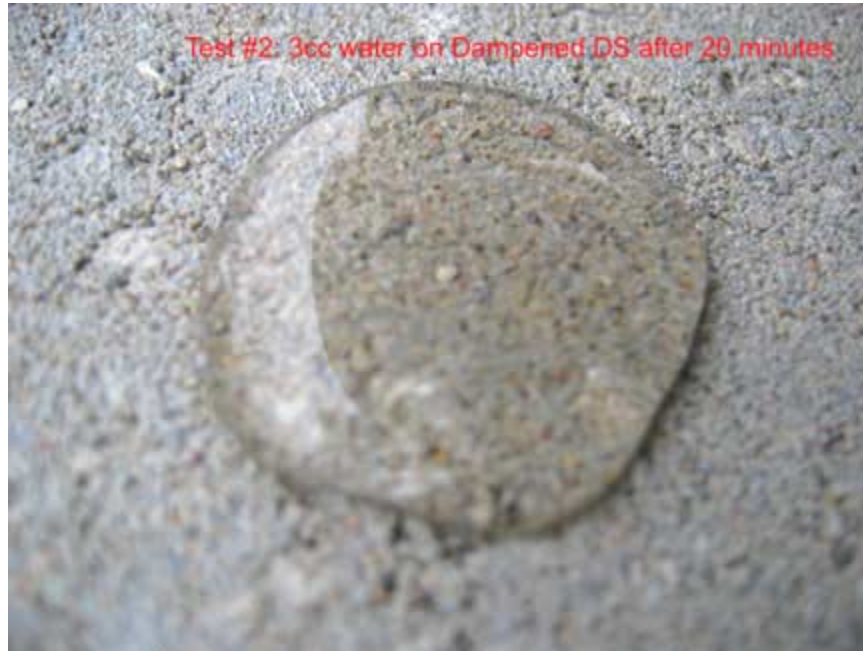
This is a closeup of the 3 cc's of water on the right hand side, which was treated with DS and then TS... after 20 minutes. The area about the size of a 50 cent piece stayed the same until it eventually evaporated more than 30 hours after application. Had that 3 ccs of water been broomed off, that area would have been dry in a few minutes. However, the beading effect does not last... it is not designed as a "beading" material. It will hold out moisture even though the surface tension does not create beading. The way Top Seal works is quite different from commonly seen sealers that advertise if it stops beading you have to reapply. That is NOT true of Top Seal because it works differently.

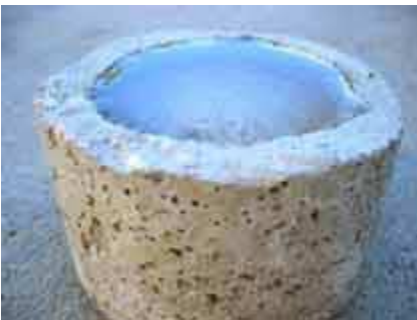
Another visual demonstration of Deep Seal and Top Seal used together:

The container above was formed from just hand mixed cement, poured into a form, then a pop can pushed into it to make a cup like concrete container. It was treated with Deep Seal and Top Seal. As you can see the concrete is porous...however it holds the water and in fact, the water is arched into a bead inside the container. This will hold water... absolutely no absorption at all for extended periods
